Example No. 1: Coating and Substrate Failure

A major supplier of automotive bearings and gear wheels applied a “protective” coating to these parts in an attempt to increase their service life. The quality and performance of the coated parts, however, proved to be drastically inferior to that of uncoated parts. SIO (Saxonian Institute of Surface Mechanics) was called in to help troubleshoot the problem. We focused on the surface interface between the parts. Fig. 1 shows a representation of a surface conforming contact between two surfaces, as shown in Fig. 2, would not occur. However, if contact points between two serious problems can occur.

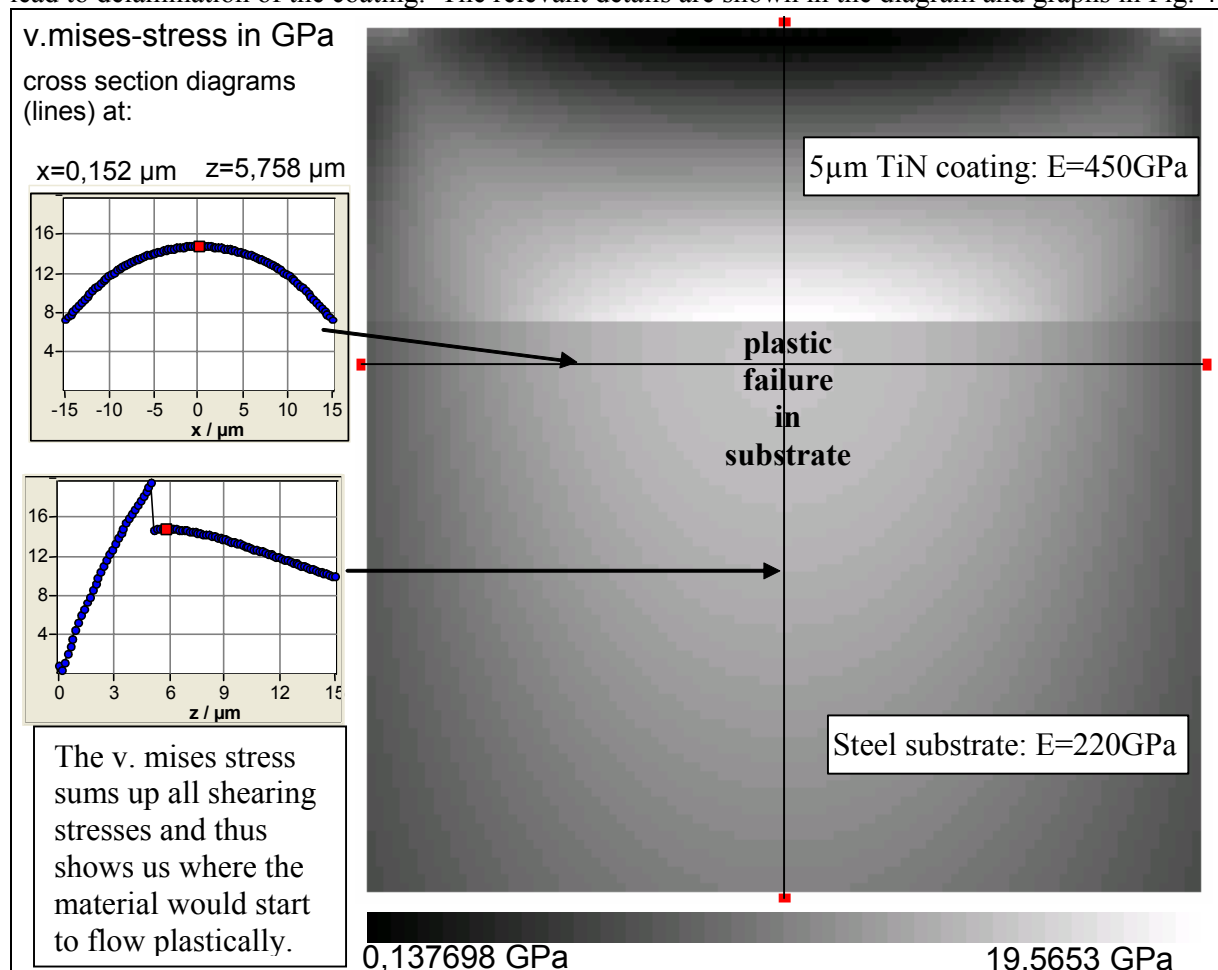
Using SIO’s FilmDoctor software, our client evaluated what would happen in a tip-to-tip contact situation and was able to determine that plastic flow had damaged the substrate metal and eventually lead to delamination of the coating. The relevant details are shown in the diagram and graphs in Fig. 4.

Fig. 4: SIO’s FilmDoctor software not only provided insight into the coating failure, but suggested ways to avoid similar problems and costly product failures in the future.
